Contract #: 04-0120F4Cty: SF/ALA Rte: 80 PM: 13.2/13.9File #: 69.28**WELDING INSPECTION REPORT****Resident Engineer:**Siegenthaler, Peter**Address:** 333 Burma Road**City:** Oakland, CA 94607**Report No:** WIR-017919**Date Inspected:** 06-Nov-2010**Project Name:** SAS Superstructure**OSM Arrival Time:** 1900**Prime Contractor:** American Bridge/Fluor Enterprises, a JV**OSM Departure Time:** 700**Contractor:** Zhenhua Port Machinery Company, Ltd (ZPMC), Changxing Island **Location:** Shanghai, China**CWI Name:** See Below**CWI Present:** Yes No**Inspected CWI report:** Yes No N/A**Rod Oven in Use:** Yes No N/A**Electrode to specification:** Yes No N/A**Weld Procedures Followed:** Yes No N/A**Qualified Welders:** Yes No N/A**Verified Joint Fit-up:** Yes No N/A**Approved Drawings:** Yes No N/A**Approved WPS:** Yes No N/A**Delayed / Cancelled:** Yes No N/A**Bridge No:** 34-0006**Component:** OBG**Summary of Items Observed:**

On this date CALTRANS OSM Quality Assurance (QA) Inspector, Mr. Paul Dawson, arrived on site at the Zhenhua Port Machinery Company (ZPMC) facility at Changxing Island, in Shanghai China, for the purpose of monitoring welding and fabrication of the San Francisco /

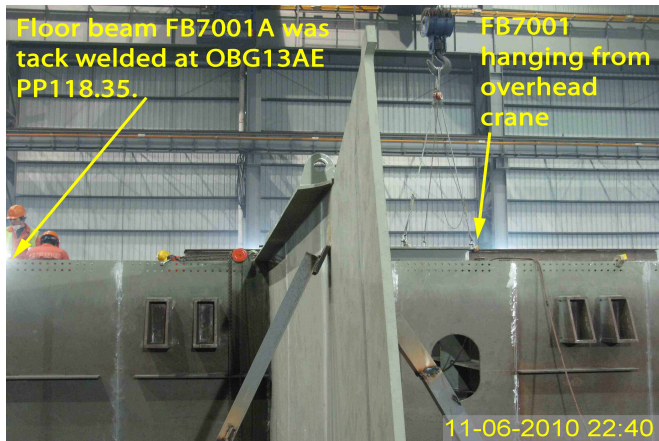
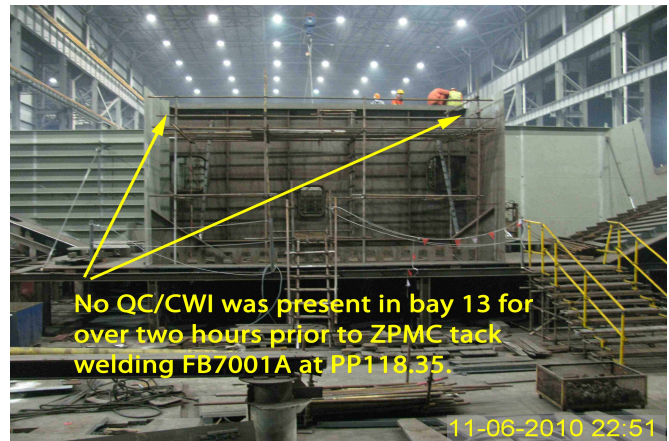
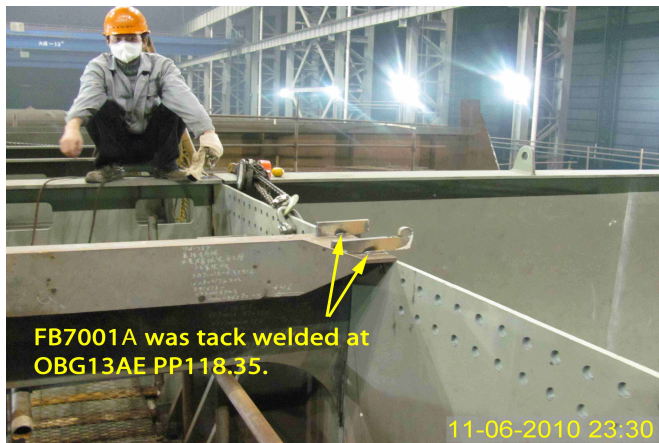
ZPMC welder 251281 used the SMAW process to perform tack welding of temporary plates to OBG segment 13AE, FB7001A without an approved Certified Welding Inspector (CWI) present. This QA Inspector was present in OBG 13AE from 2200 hrs to 2330 hours, during which time no Certified Welding Inspector was present. This QA notified ZPMC CWI Mr. Lv Li Qing who was performing CWI duties in bay 13 that ZPMC personnel had performing welding of FB7001A in bay 14 without any CWI being present. ZPMC CWI Mr. Lv Li Qing stated he

had not performed any weld monitoring in bay 14 after 2200 hours because he had not been informed any welding of OBG segment 13 would be taking place after 2200 hours. See the photographs below for additional information.
